Manhole Inspection Summary

Manhole # S21II_051MH

Inspection ☐ Is Incomplete Rating: **4) Poor**

Location Address: **1702 PRESBURY ST**

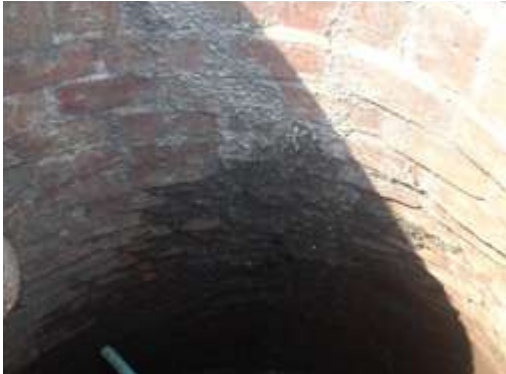
Defect 5

Infiltration: ☐ None ☐ Joint ☐ Cracks ☐ Mortar ☐ Roots ☒ **Wall**

INFILTRATION OF CORBEL

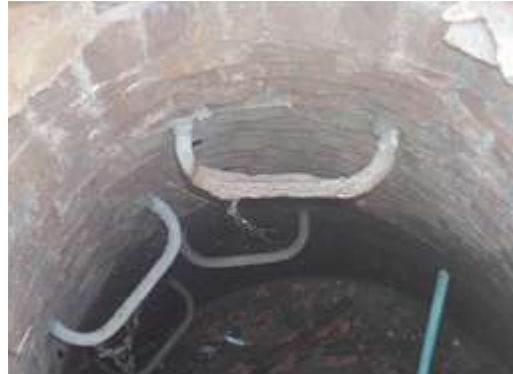
Defect 4

Count: **4** Missing: **0** ☒ **Corroded**

CORRODED STEPS

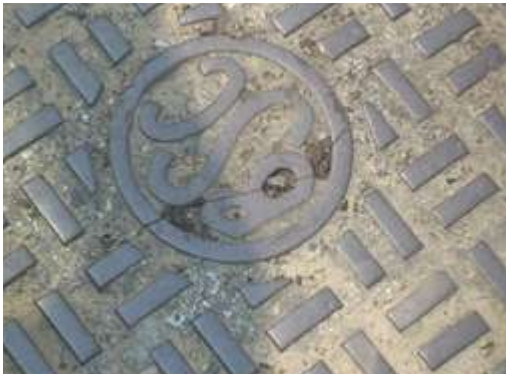
Defect 3

Condition: **Cracked**

CRACKED LID

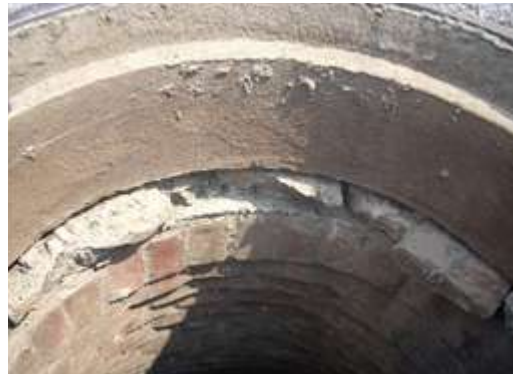
Defect 2

Condition: ☐ Sound ☐ Cracked ☐ Root Intrusion ☐ Loose Brick ☒ **Deteriorated**

DETERIORATED CHIMNEY

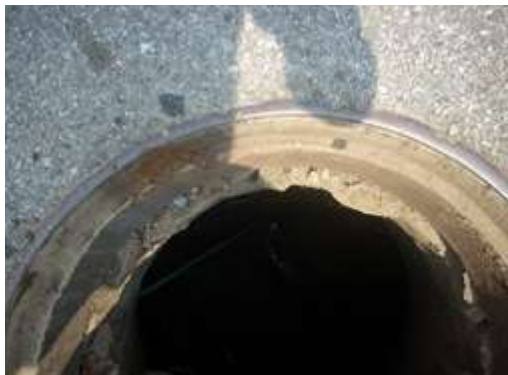
Defect 1

Offset: **2** (in.)

FRAME OFFSET

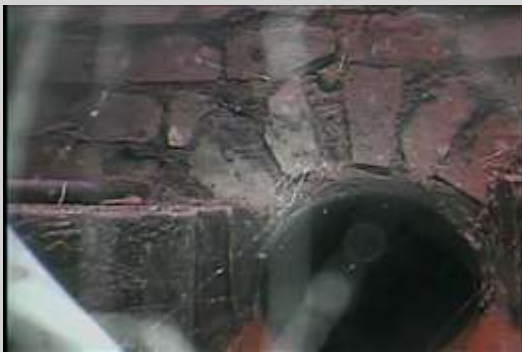
12 O'Clock Outflow

8 in. Circular Gravity Sewer
Pipe Out @ 12 O'Clock

Pipe Height: **8.4** (in.) Rod and Bar (Angled)
Pipe Material: **Clay** ☐ Pipe Lined
Invert Depth: **8.42** (ft.) Flow Characteristics: **None**
Deposits: ☒ None ☐ **Mud** ☐ Sludge ☐ Debris ☐ Grease
Silt Depth: (in.) Deposits Extent:
Infiltration: **None** Pipe Seal Cond: **Broken**

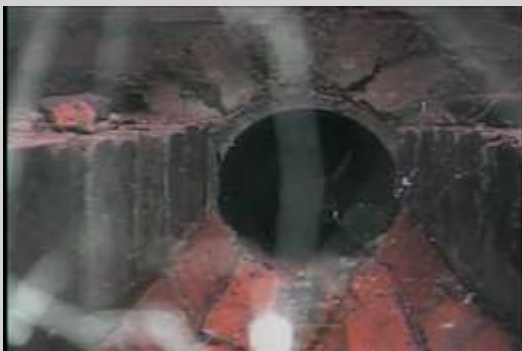
4 O'Clock Inflow

8 in. Circular Gravity Sewer
Pipe In @ 4 O'Clock

Pipe Height: **7.2** (in.) Rod and Bar (Angled)
Pipe Material: **Clay** ☐ Pipe Lined
Invert Depth: **8.21** (ft.) Flow Characteristics: **None**
Deposits: ☒ None ☐ **Mud** ☐ Sludge ☐ Debris ☐ Grease
Silt Depth: (in.) Deposits Extent:
Infiltration: **None** Pipe Seal Cond: **Broken**

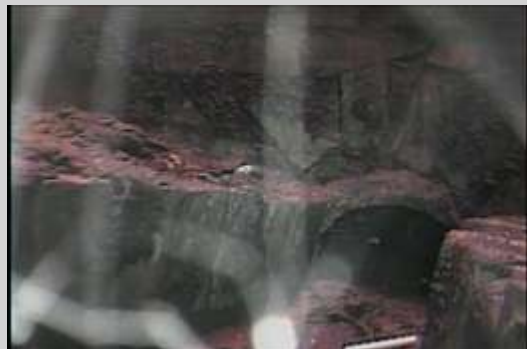
9 O'Clock Inflow

Deposits: ☐ None ☒ **Mud** ☐ Sludge ☐ Debris ☐ Grease

Silt Depth: **3** (in.) Deposits Extent: **Light**

Connects To: **Stub connection / abandoned**
